MINERAL INSPECTION FORM
NEZ PERCE-CLEARWATER NATIONAL FOREST'S

Project:	Badger Shaft #2	Operator/Claimant: Unknown; abandoned mine lands evaluation
Geographic Location:	Township: 27N Range: 8E Section: 19 <u>NW</u> ¹ / ₄	
	GPS (UTM): 11T 615257E, 5057627N	
Date/Time:	6/11/14 / 2:30PM	Day of Week: Wednesday Weather: Sunny and warm
USFS Personnel on Site:	Martin Jones	
Designated Operator's Rep. on Site:	NA	
Others on Site:	Ecosystem Research Group staff: Craig Jourdonnais (wildlife biologist), Steve VanFossen (soil scientist), and Connie Brown (geologist/hydrologist)	
Date POO Received/Authorized:	No POO submitted; reclamation evaluation	NOI Date: NA

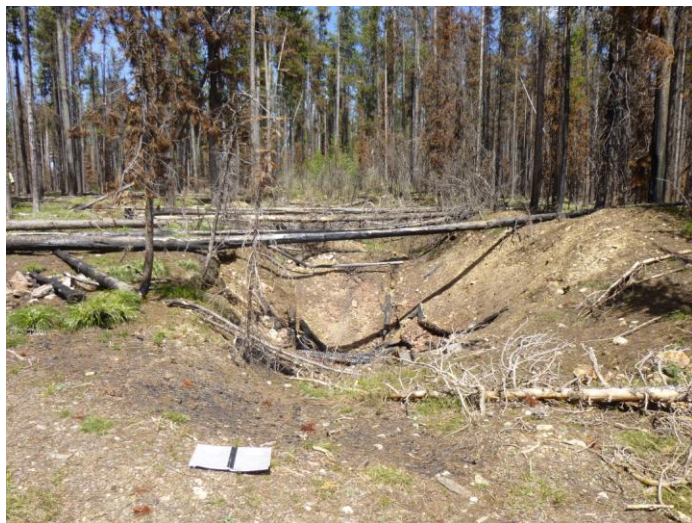
We visited the Badger Shaft #2 on 6/11/14 with minerals administrator Martin Jones to evaluate potential impacts associated with the prospective mine closure. There is a short (less than 500 feet) access road that leads from FS Road 311 to the Badger Shaft #2. The shaft is partially collapsed and appeared to be approximately 20 feet deep. The shaft and shallow trench that extends from it are roughly 60 feet in length. The shaft is a safety risk because an ATV could be driven into the area and the opening of the shaft is hard to detect from the top of the adjacent slope. There is a mound of fill on-site and it was assumed that this material had been removed from the trench and shaft. The fill pile is moderately vegetated and could be used to backfill the shaft and trench although additional material may be needed. The area surrounding the trench and shaft was lightly burned in a mosaic pattern during the 2010 McGuire Fire and the duff/litter layer is intact and bear grass was thriving at the time of the visit. No soil or water issues were identified.

Looking north at collapsed shaft and trench from edge of access road.

Ask USFS engineer and road specialist to evaluate site for shaft closure options.

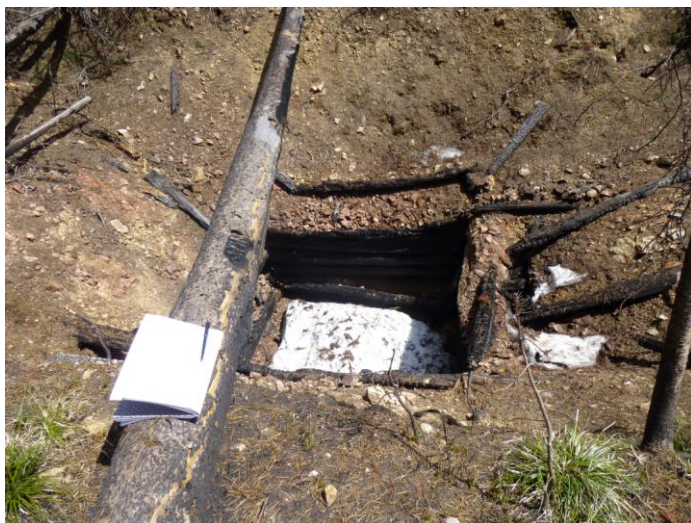
Collapsed Badger Shaft #2 (photo taken looking east).

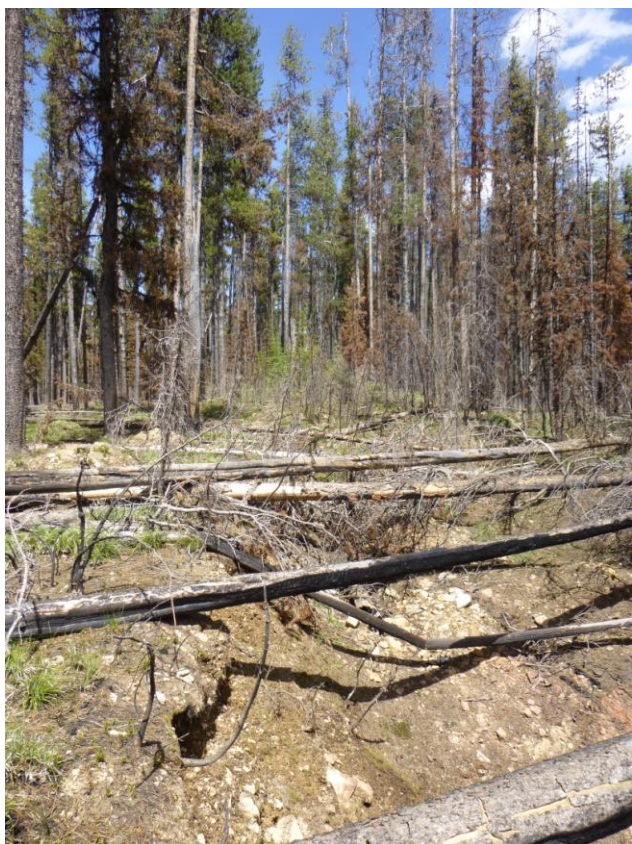
Looking north at trench that extends from shaft.

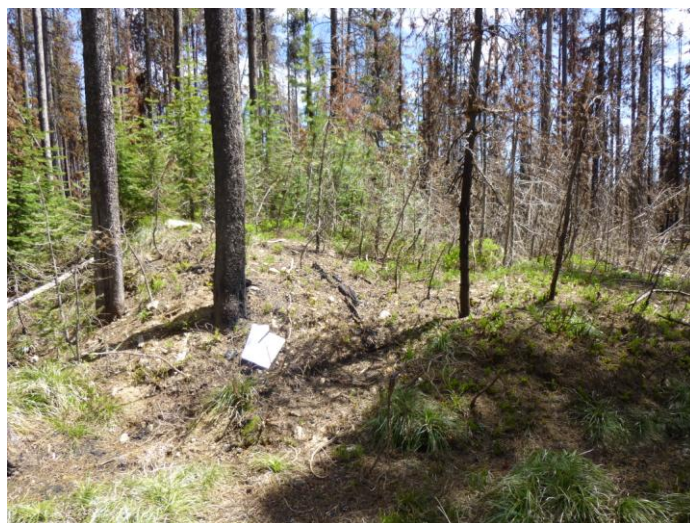
Vegetated fill on-site that could be used to backfill trench (photo taken looking northeast).
